Project  
**Heol Dewi Sant**  
**Cwmbran**

Drawing Title  
**EXISTING FEATURES AND TREE SURVEY**

Drawing No  
**173**  
**2018/106**

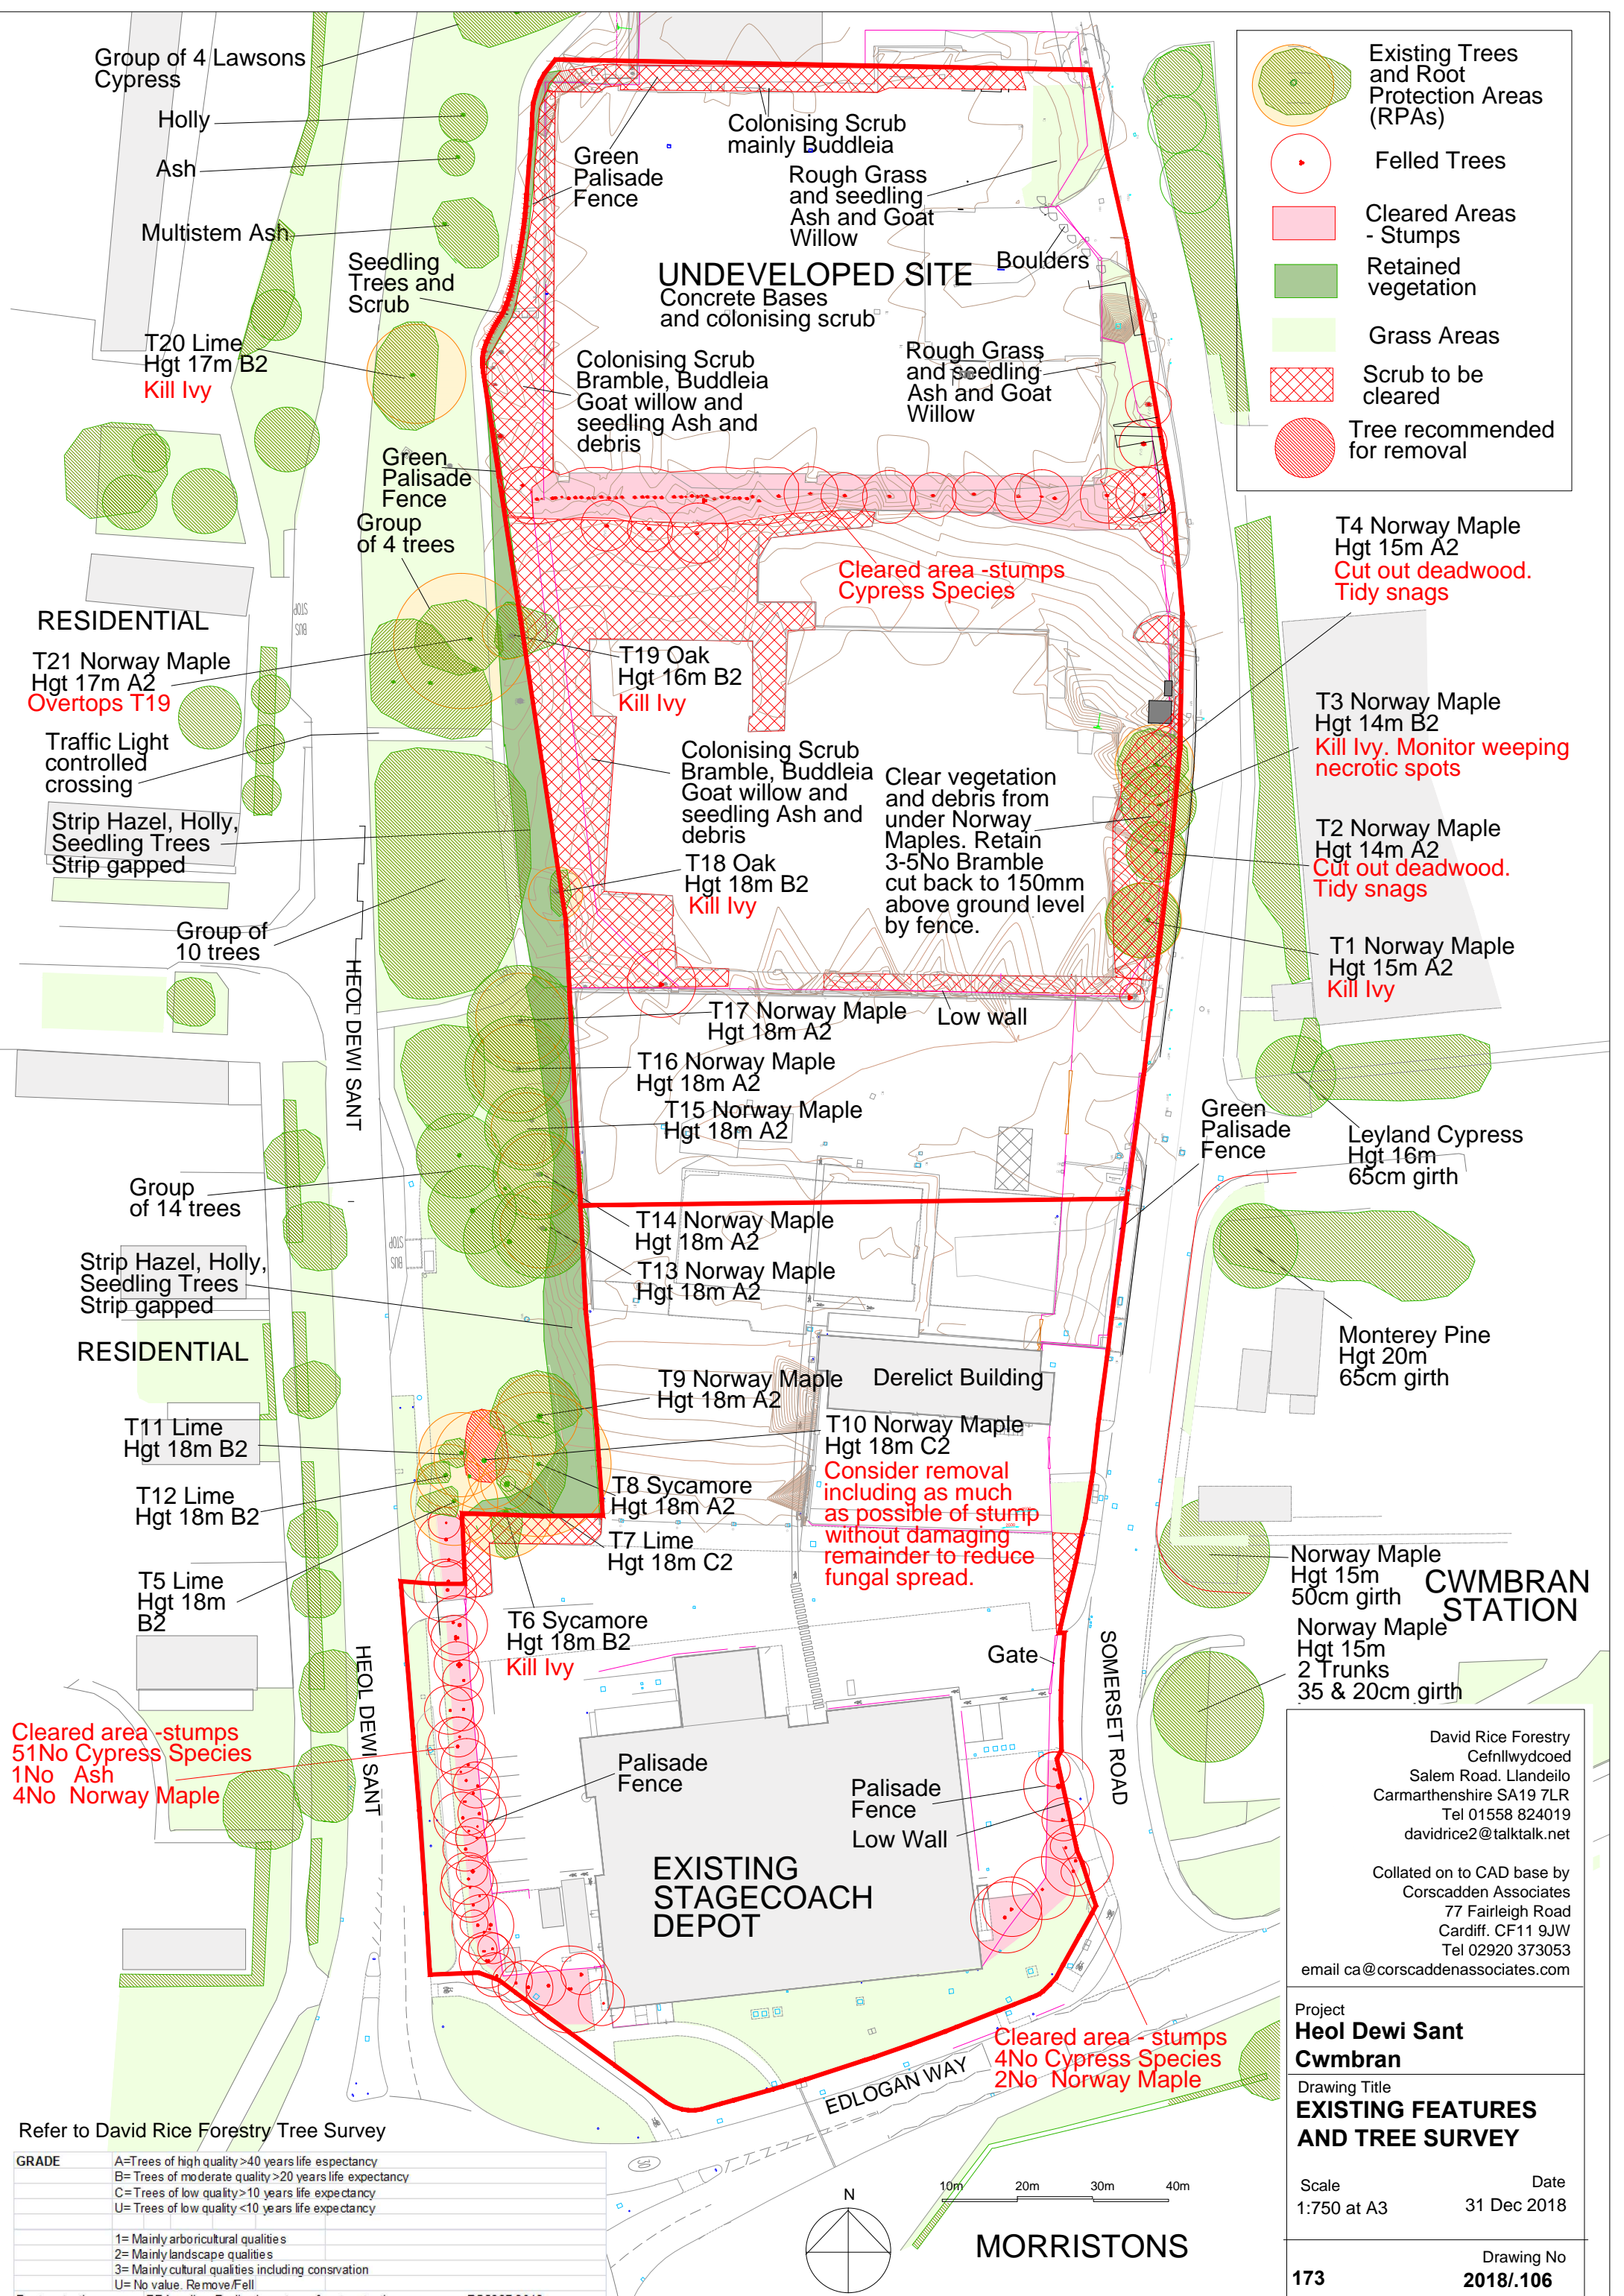
T20 Lime Hgt 17m B2 Kill Ivy

T21 Norway Maple Hgt 17m A2 Overtops T19

T11 Lime Hgt 18m B2

T12 Lime Hgt 18m B2

T5 Lime Hgt 18m B2

Cleared area -stumps 51No Cypress Species 1No Ash 4No Norway Maple

T19 Oak Hgt 16m B2 Kill Ivy

T18 Oak Hgt 18m B2 Kill Ivy

T17 Norway Maple Hgt 18m A2

T16 Norway Maple Hgt 18m A2

T15 Norway Maple Hgt 18m A2

T14 Norway Maple Hgt 18m A2

T13 Norway Maple Hgt 18m A2

T9 Norway Maple Hgt 18m A2

T10 Norway Maple Hgt 18m C2 Consider removal including as much as possible of stump without damaging remainder to reduce fungal spread.

T8 Sycamore Hgt 18m A2

T7 Lime Hgt 18m C2

T6 Sycamore Hgt 18m B2 Kill Ivy

T4 Norway Maple Hgt 15m A2 Cut out deadwood. Tidy snags

T3 Norway Maple Hgt 14m B2 Kill Ivy. Monitor weeping necrotic spots

T2 Norway Maple Hgt 14m A2 Cut out deadwood. Tidy snags

T1 Norway Maple Hgt 15m A2 Kill Ivy

Clear vegetation and debris from under Norway Maples. Retain 3-5No Bramble cut back to 150mm above ground level by fence.
